TRANSPORTATION RESEARCH CENTER

ON-SITE AIR BAG INVESTIGATION

CASE NO. - 95-06

This report concerns a motor vehicle crash involving an air bag equipped 1990 Lincoln Continental, 4-door sedan and a 1993 Chevrolet, G-20 (3/4 ton), 4x2, conversion van occurring on [REDACTED], [REDACTED] 1995 at 5:25 p.m., in [REDACTED], Indiana on a [REDACTED]. This crash is of special interest because the case vehicle's deploying driver side air bag caused fatal injuries to the case vehicle's driver.

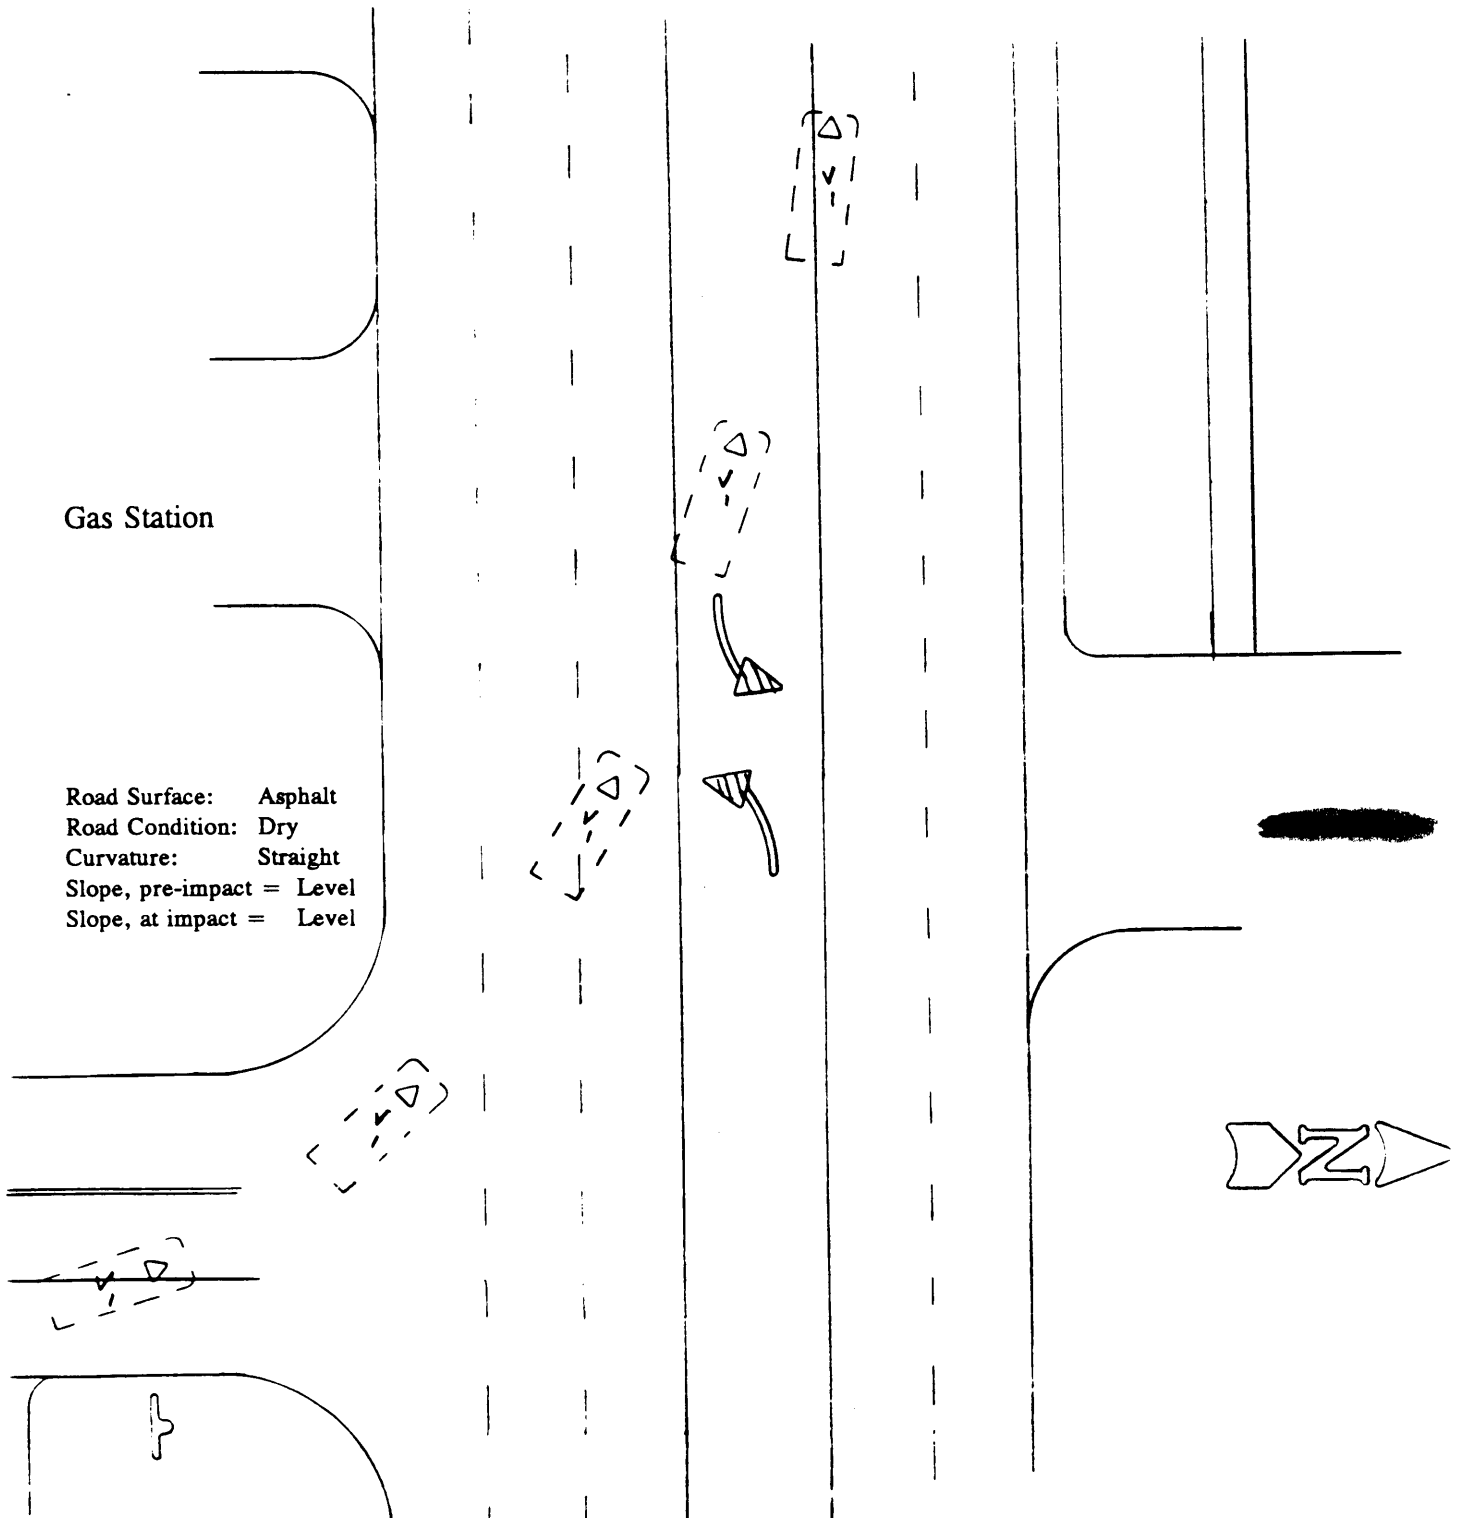
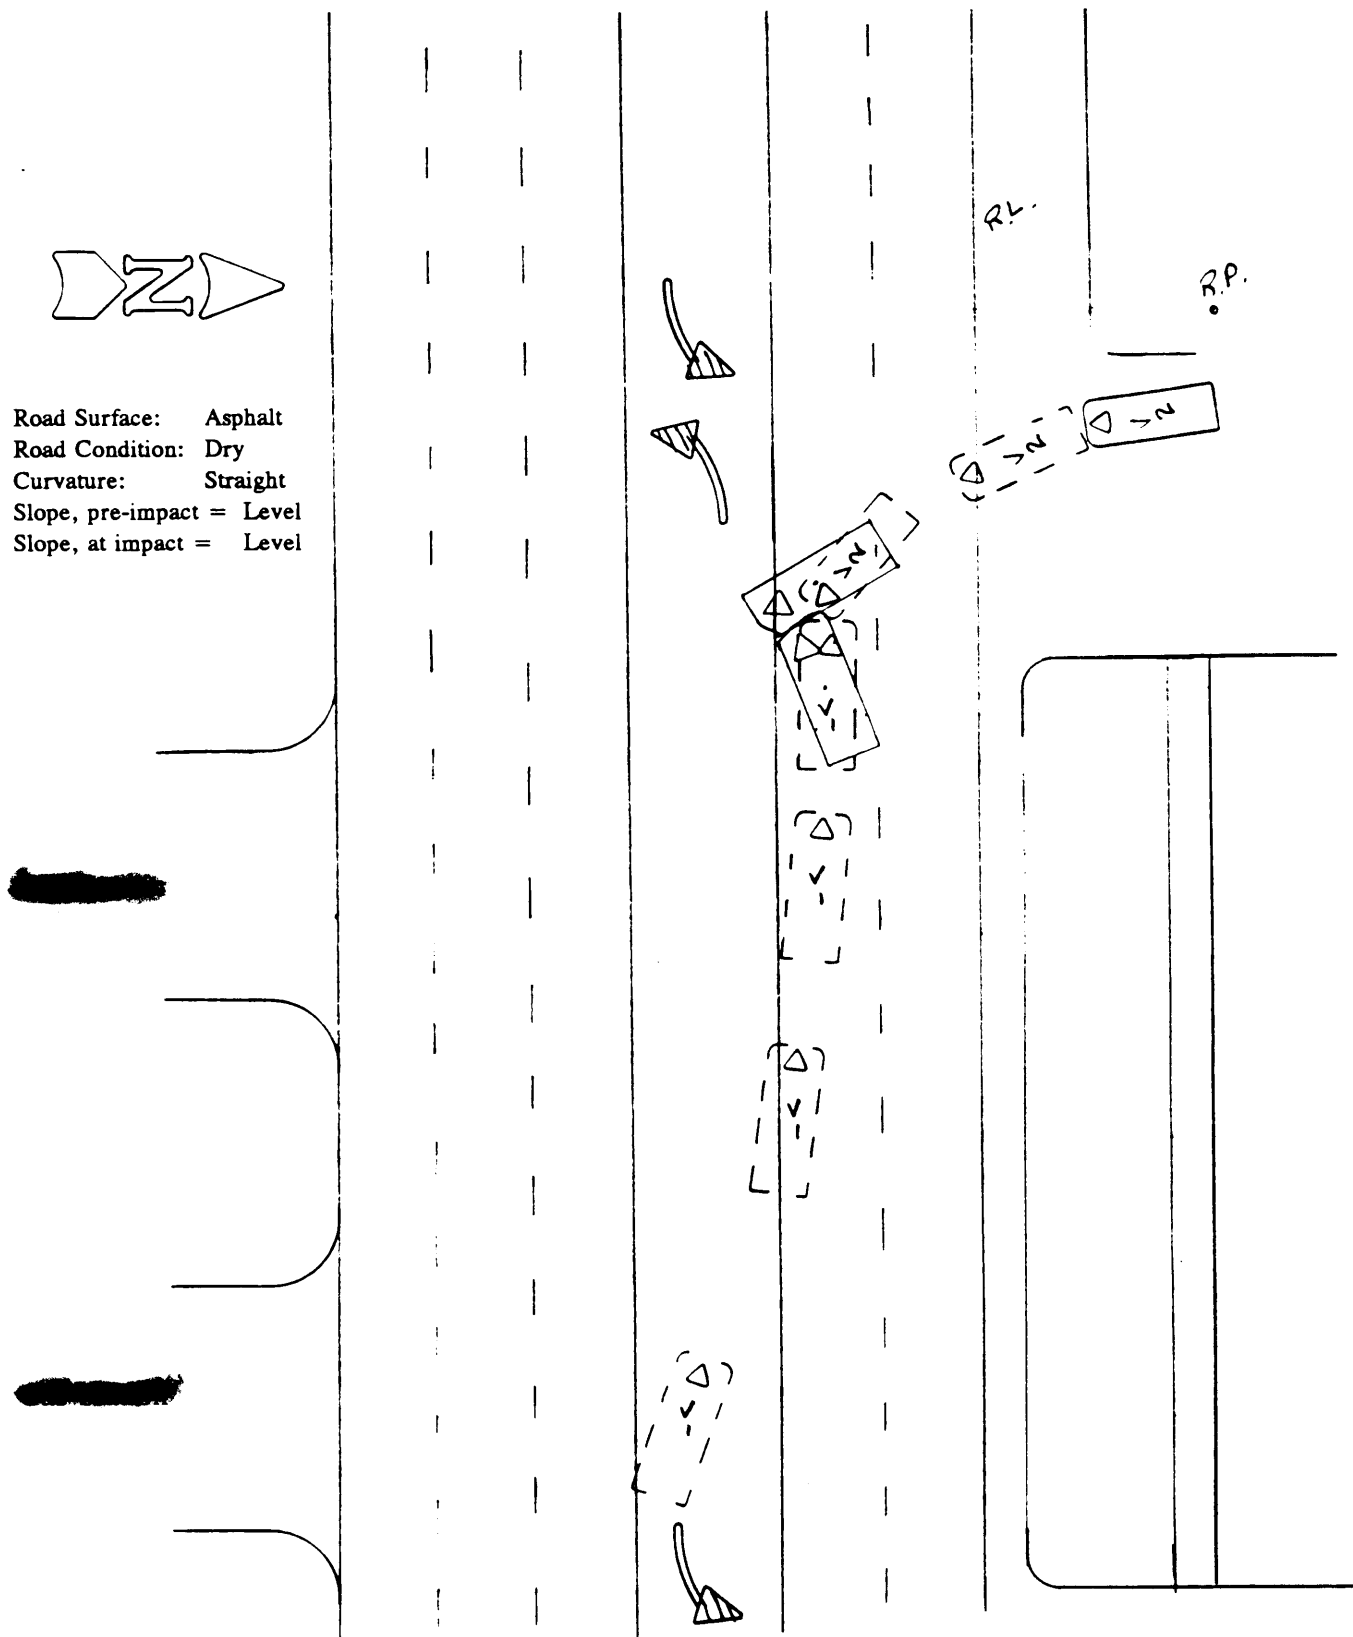
Scale: 1 cm = 2.5 m
(prior to reduction @ 92%)

Road Surface: Asphalt
 Road Condition: Dry
 Curvature: Straight
 Slope, pre-impact = Level
 Slope, at impact = Level

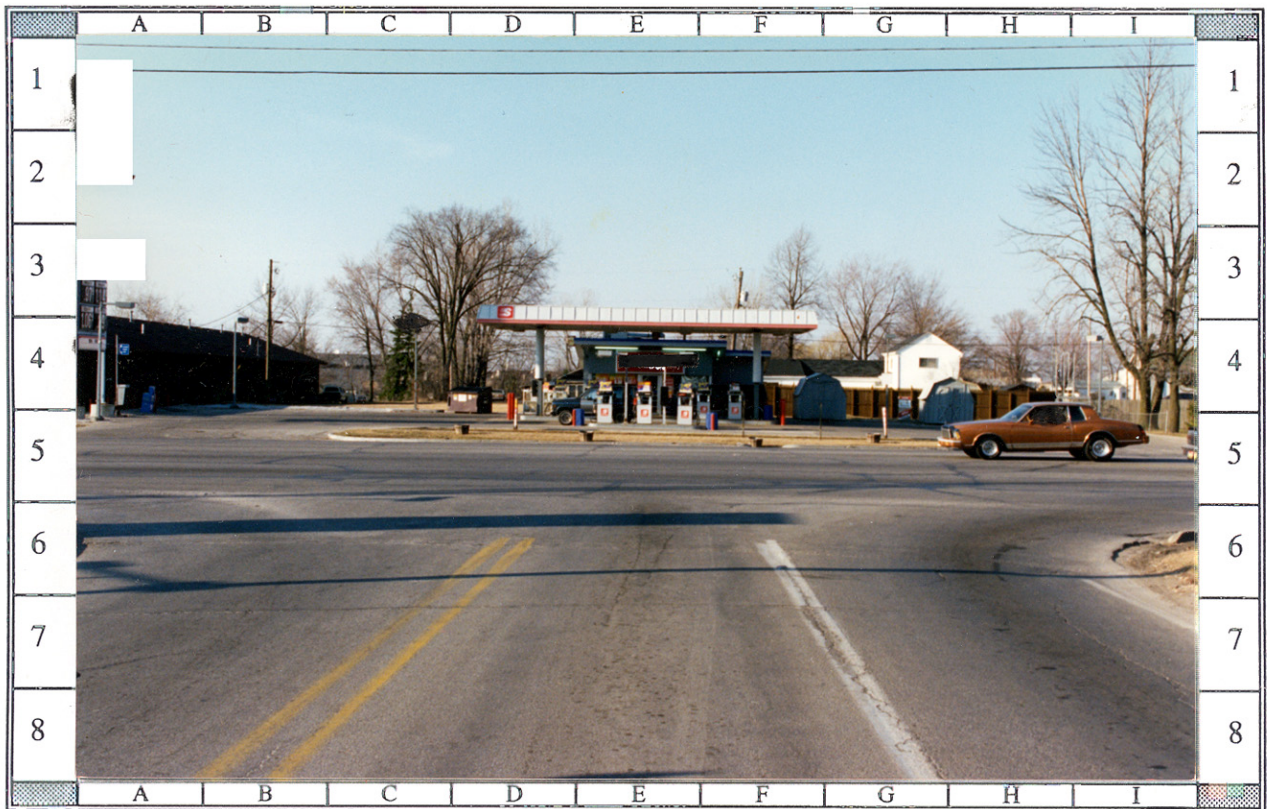
01 -- 1990 Lincoln Continental begins its left-hand turn from this intersecting roadway located on the south side

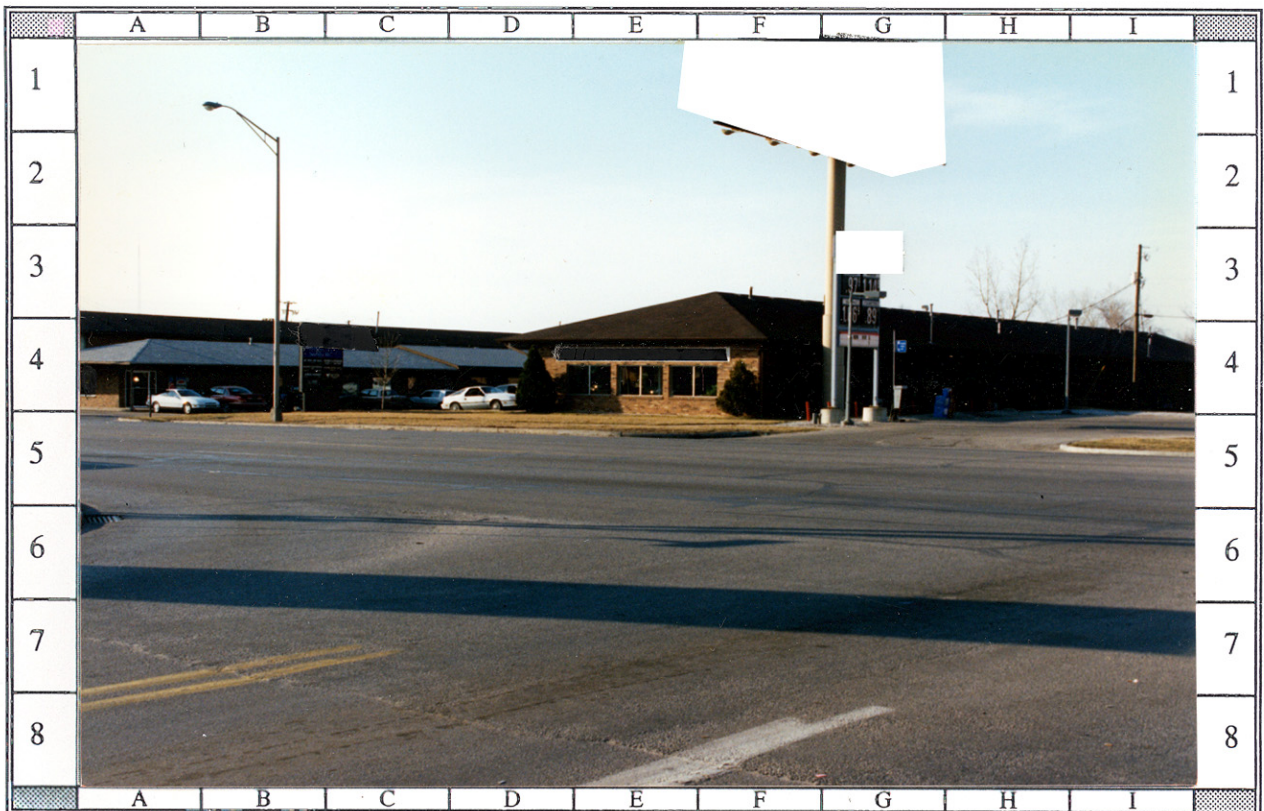
02 -- 1990 Lincoln Continental's north-northwest travel path approximately 50 m (164 ft) from point of impact

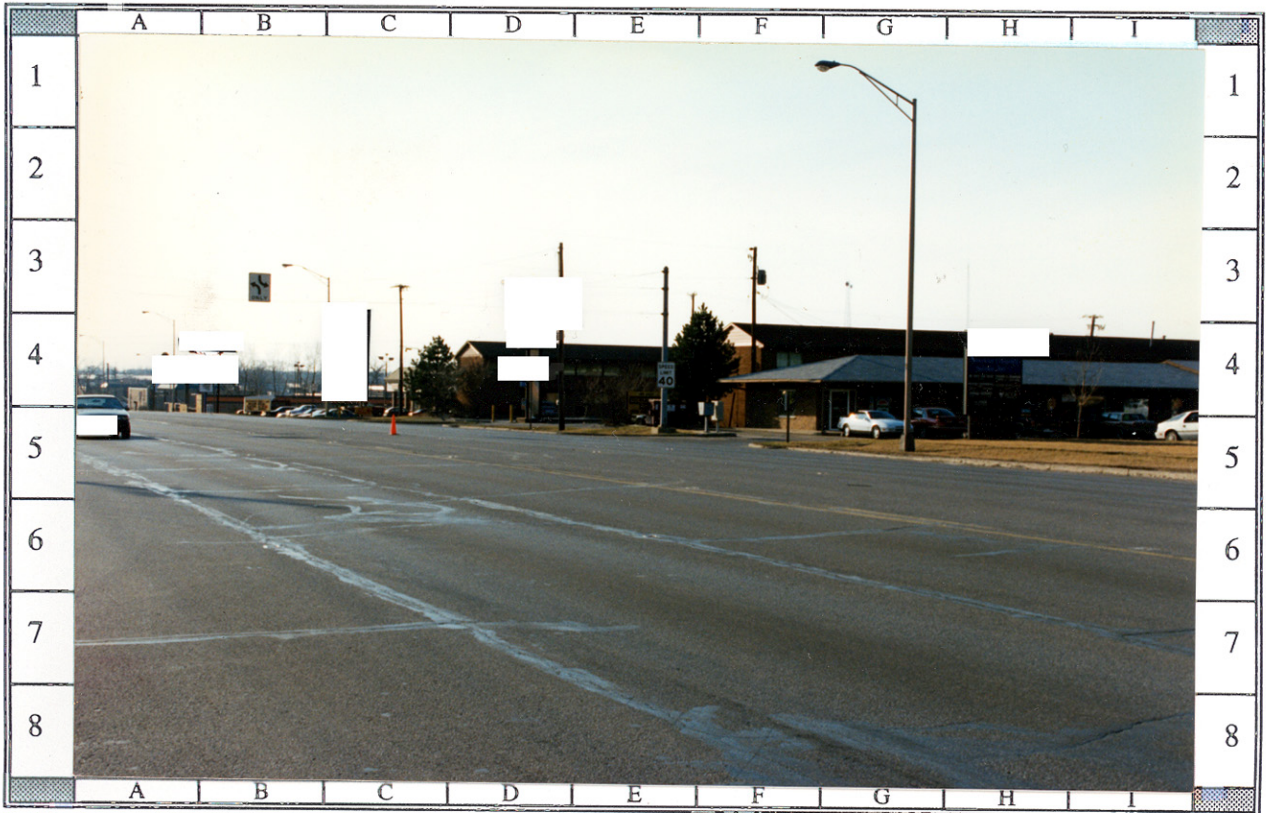
03 -- 1990 Lincoln Continental's northwest travel path approximately 40 m (131 ft) from point of impact (red traffic cone)

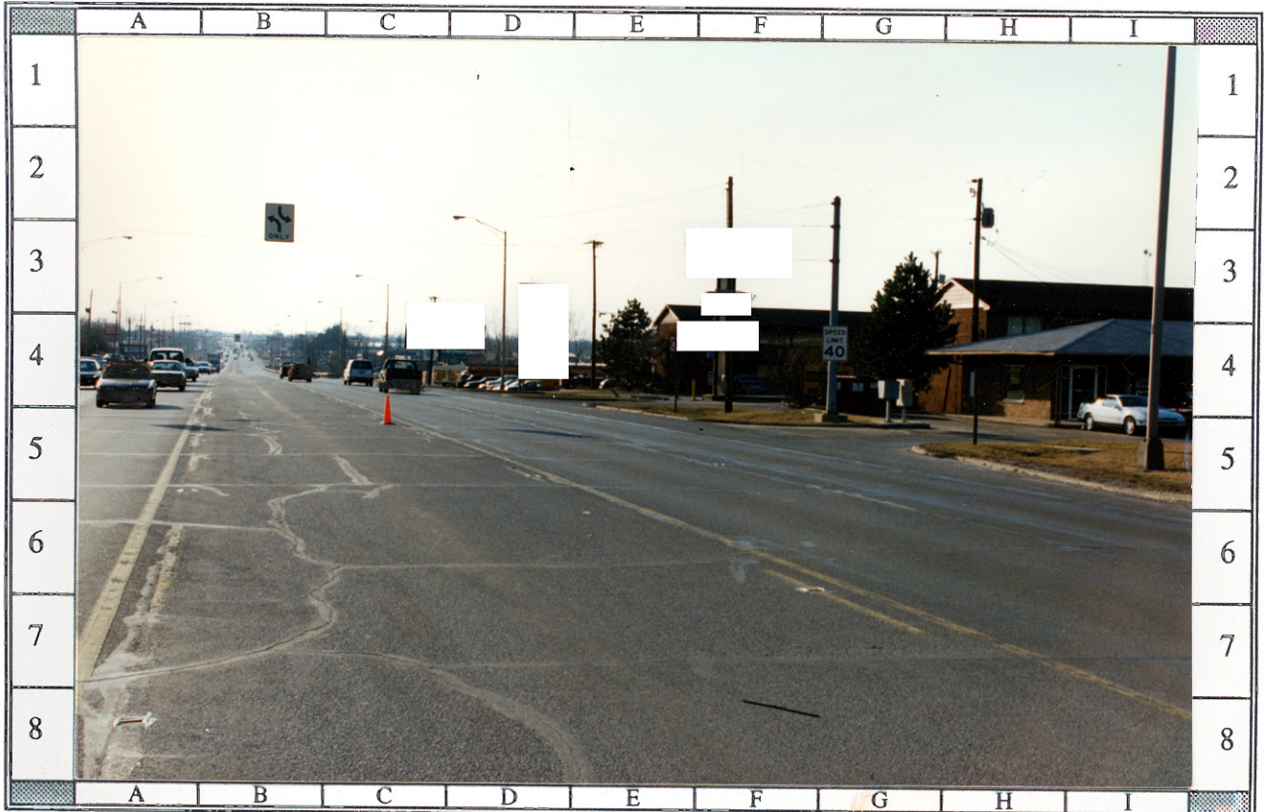
04 -- 1990 Lincoln Continental's west-northwest travel path approximately 25 m (82 ft) from point of impact (red traffic cone)

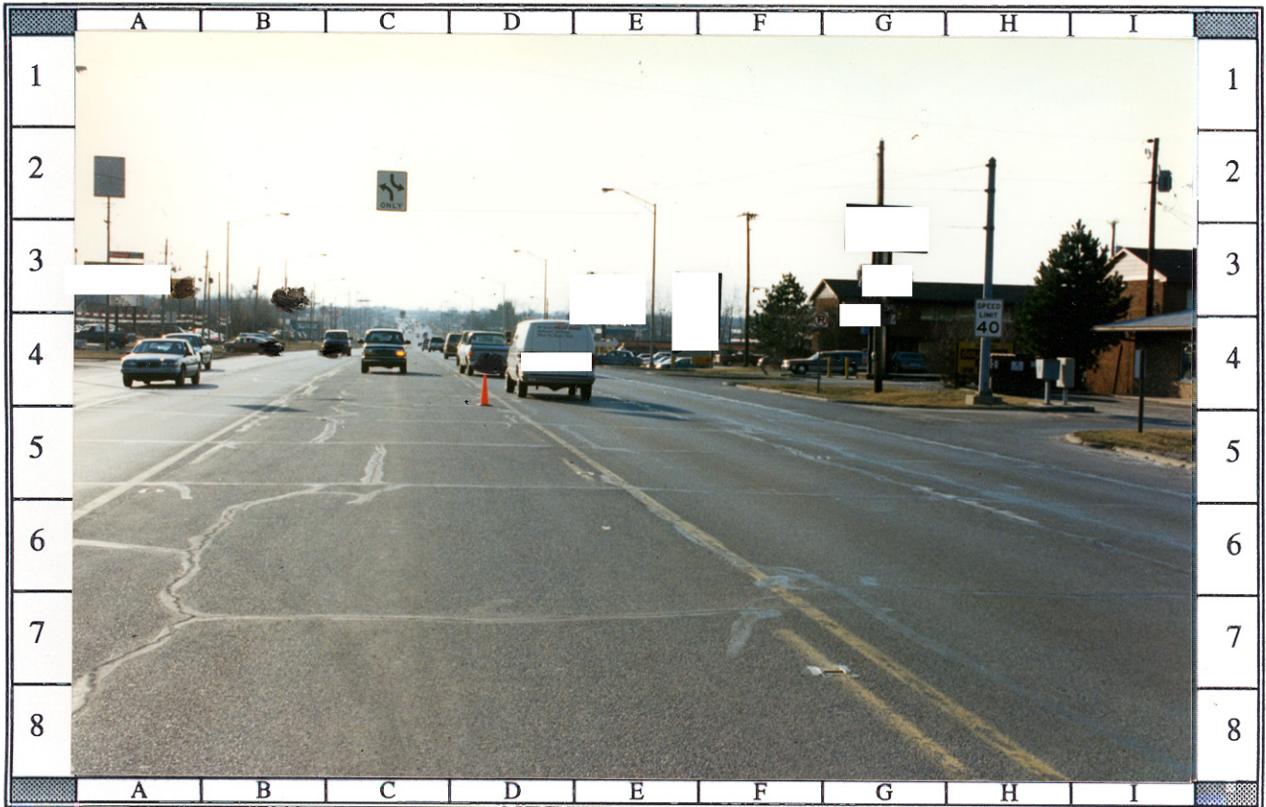
05 -- 1990 Lincoln Continental's west-northwest travel path approximately 15 m (49 ft) from point of impact (red traffic cone)

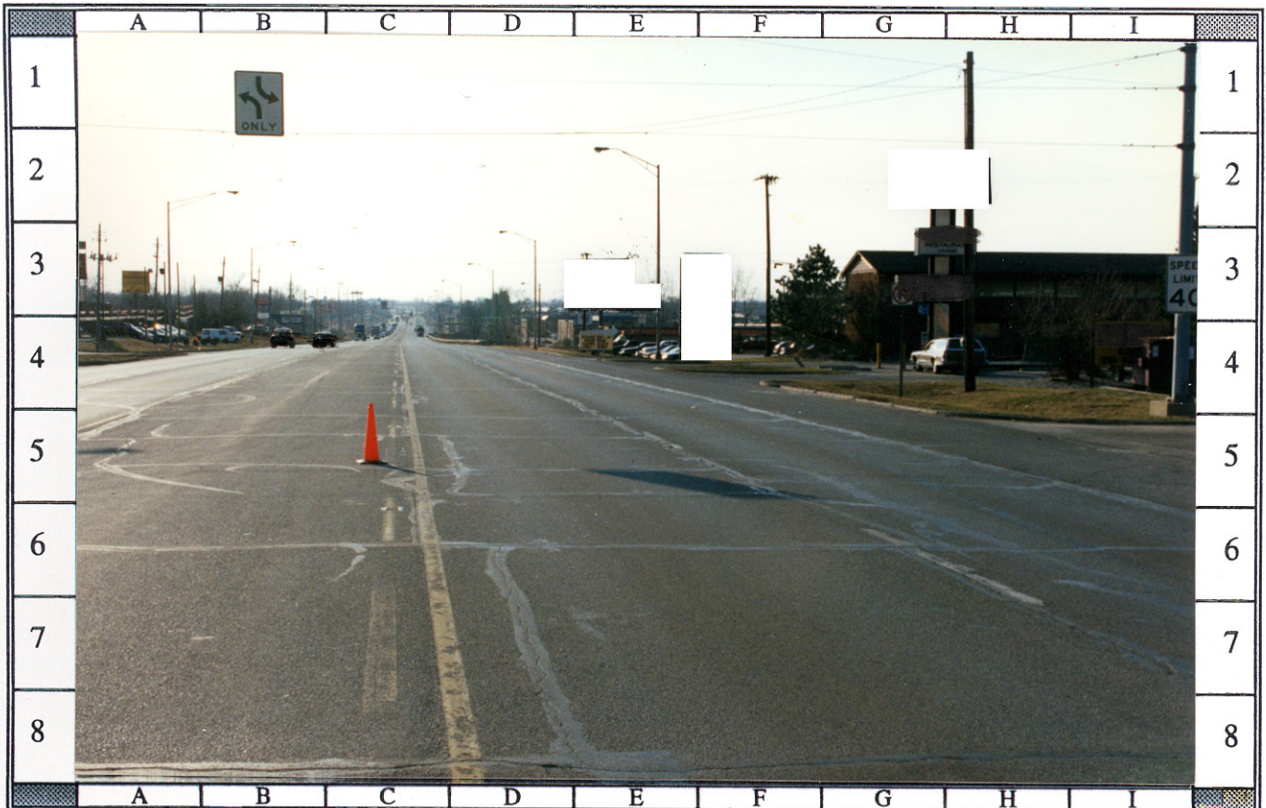
06 -- 1990 Lincoln Continental's westward travel path entering inside westbound lane ~ 7 m (23 ft) from point of impact (red cone)

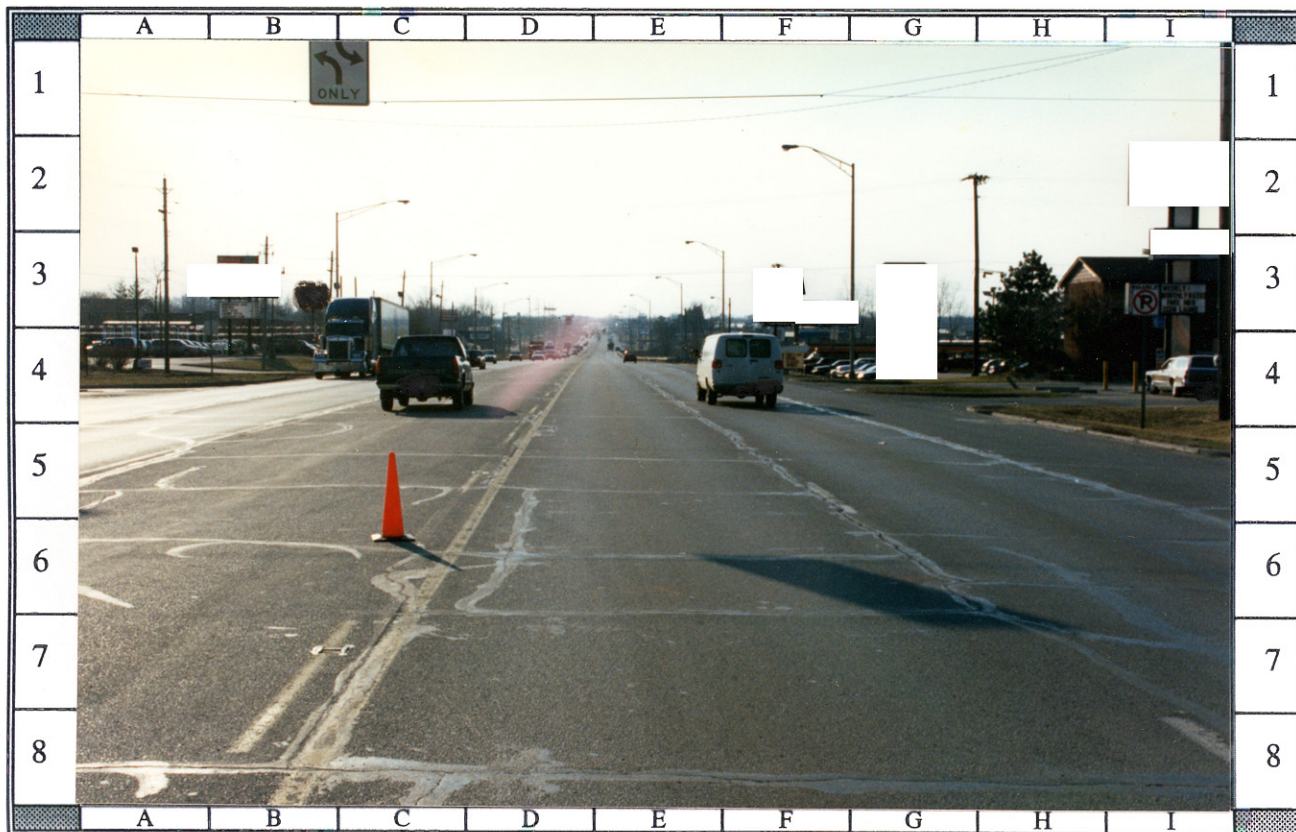
07 -- 1990 Lincoln Continental's westward travel path in inside west-bound travel lane just prior to impact (near red traffic cone)

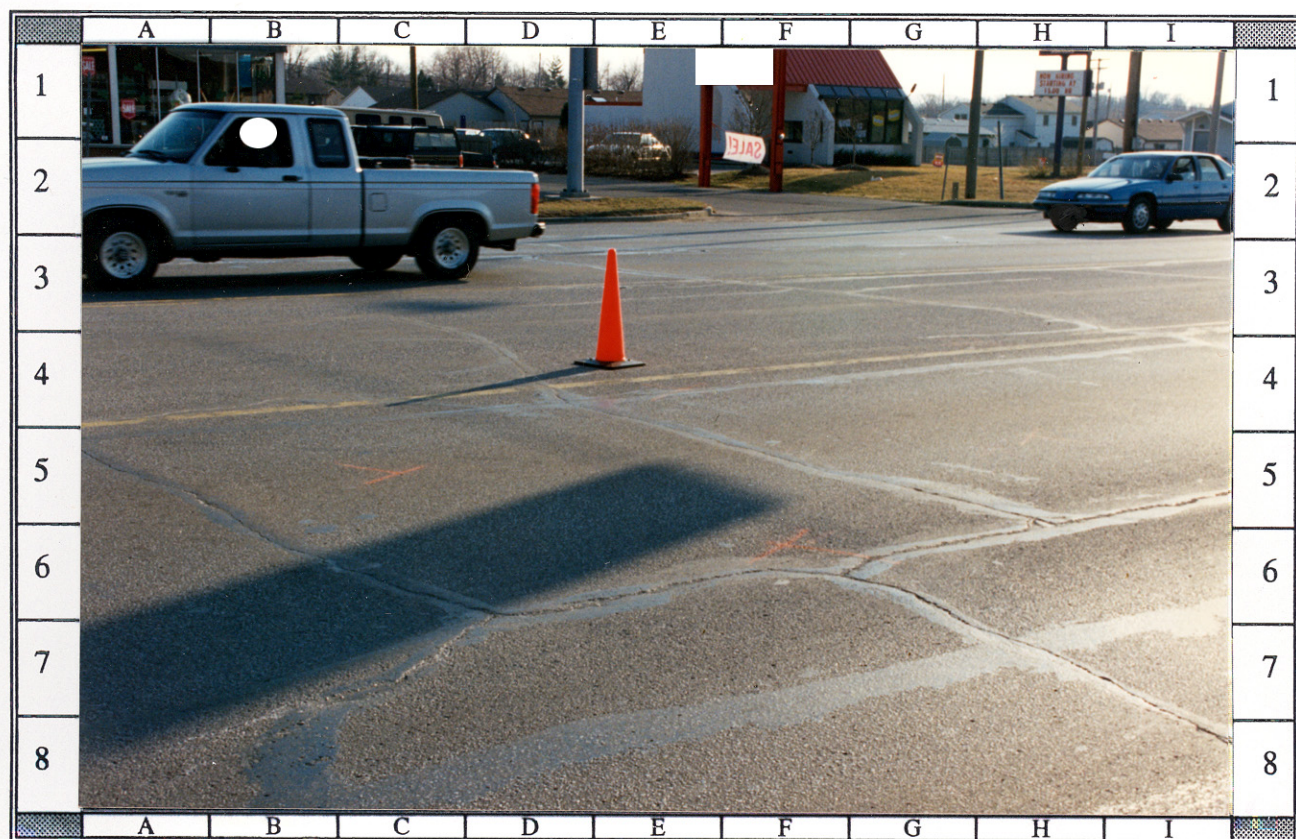
08 -- Southwest view of FRP scene marking symbols representing the '90 Lincoln Continental's rear wheels [cells C5 (LR) & F6 (RR)]

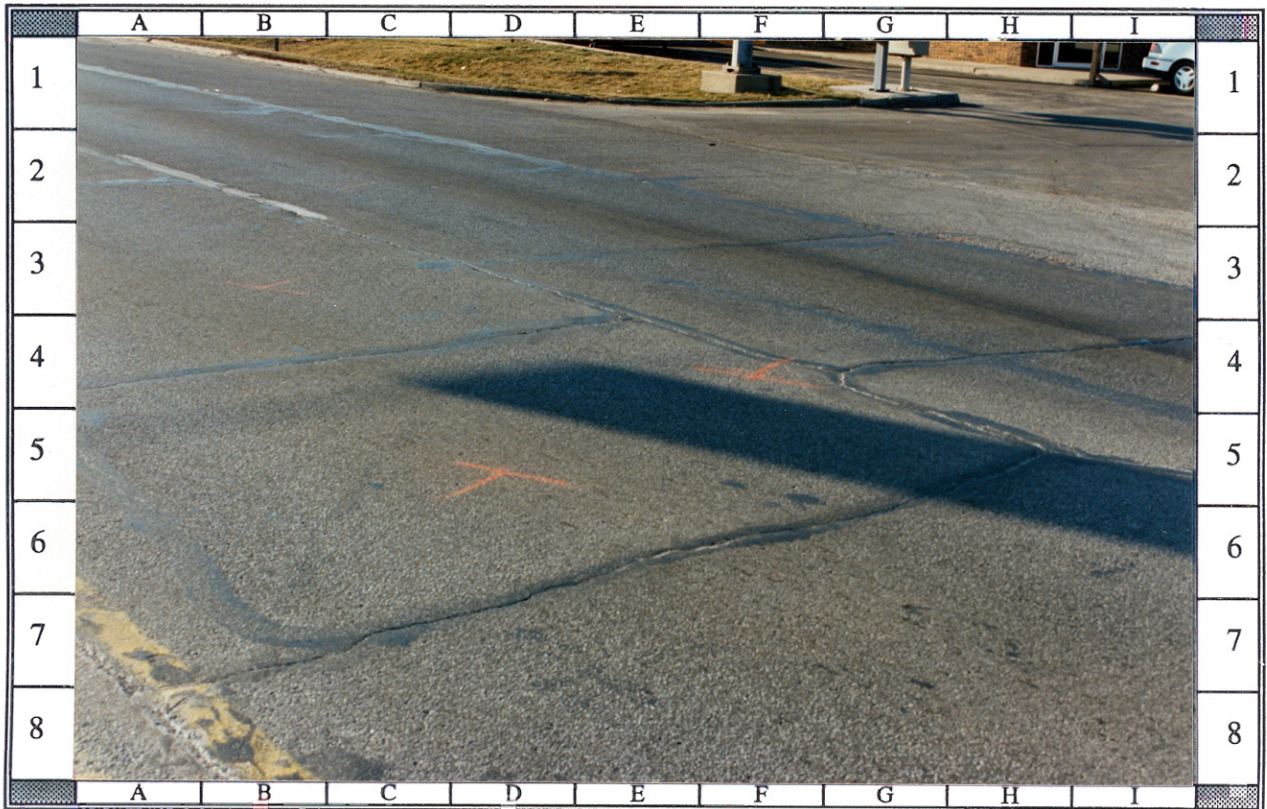
09 -- Northwest view of FRP scene marking symbols representing the '90 Lincoln Continental's rear wheels [cells D5 (LR) & F4 (RR)]

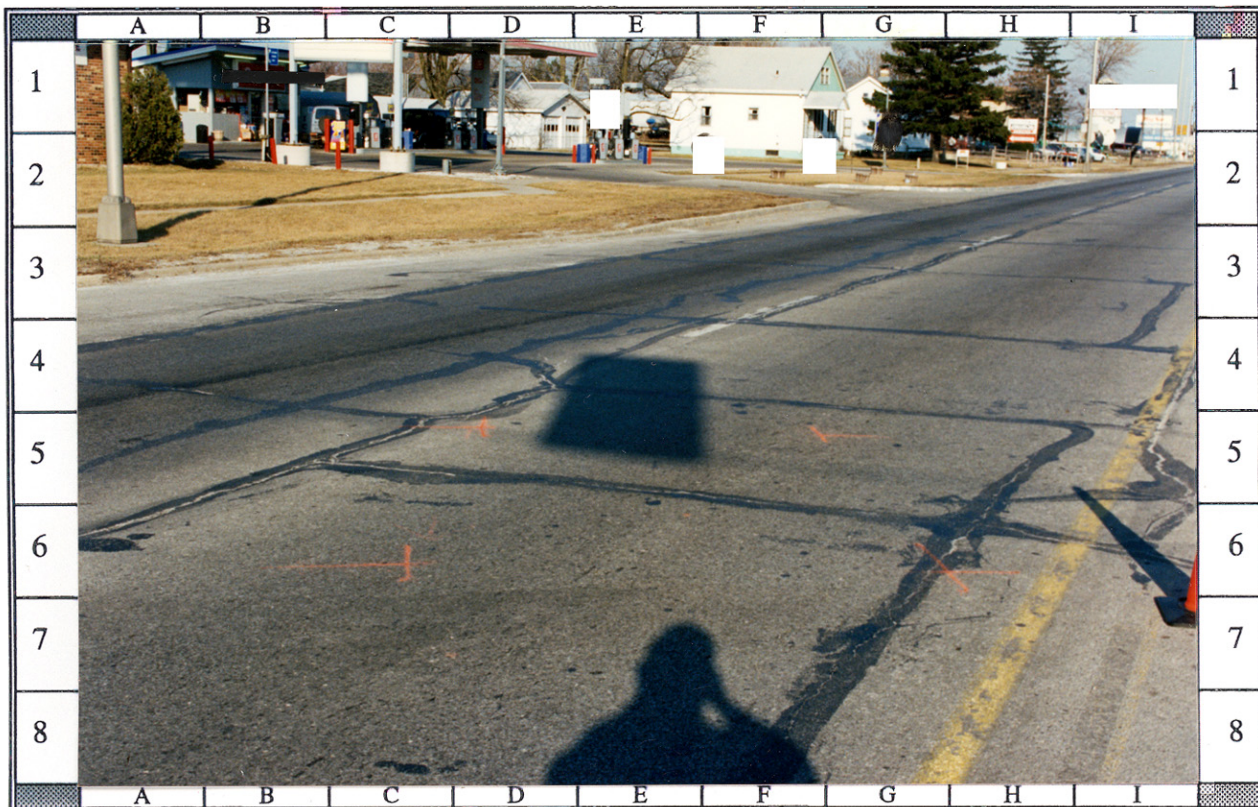
11 -- Northeast view of FRP scene marking symbols representing the '90 Lincoln Continental's four tires [cells C6 (RF) & G5--F5 (LR)]

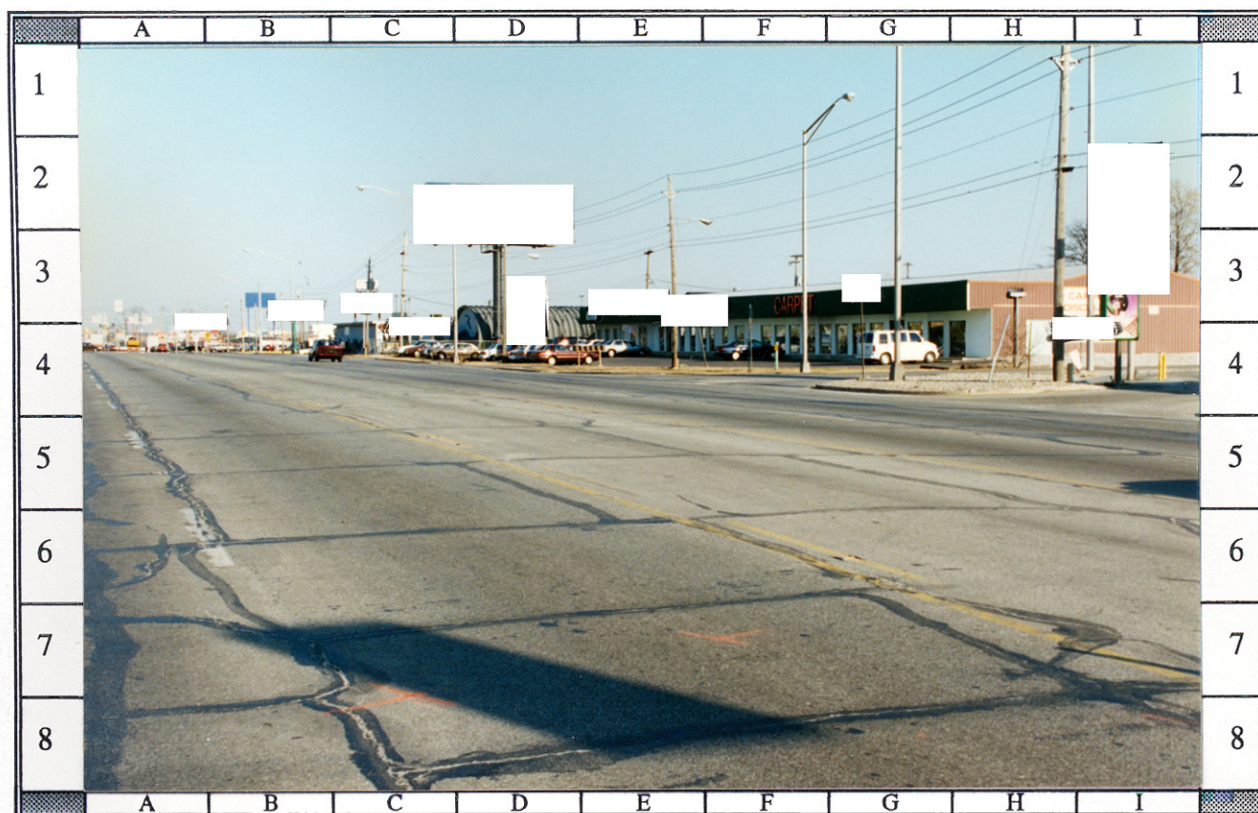
12 -- Southeast view of '90 Lincoln Continental's travel path from intersecting roadway (cells E4--F4) to FRP [C7 (RR) & F7 (LR)]

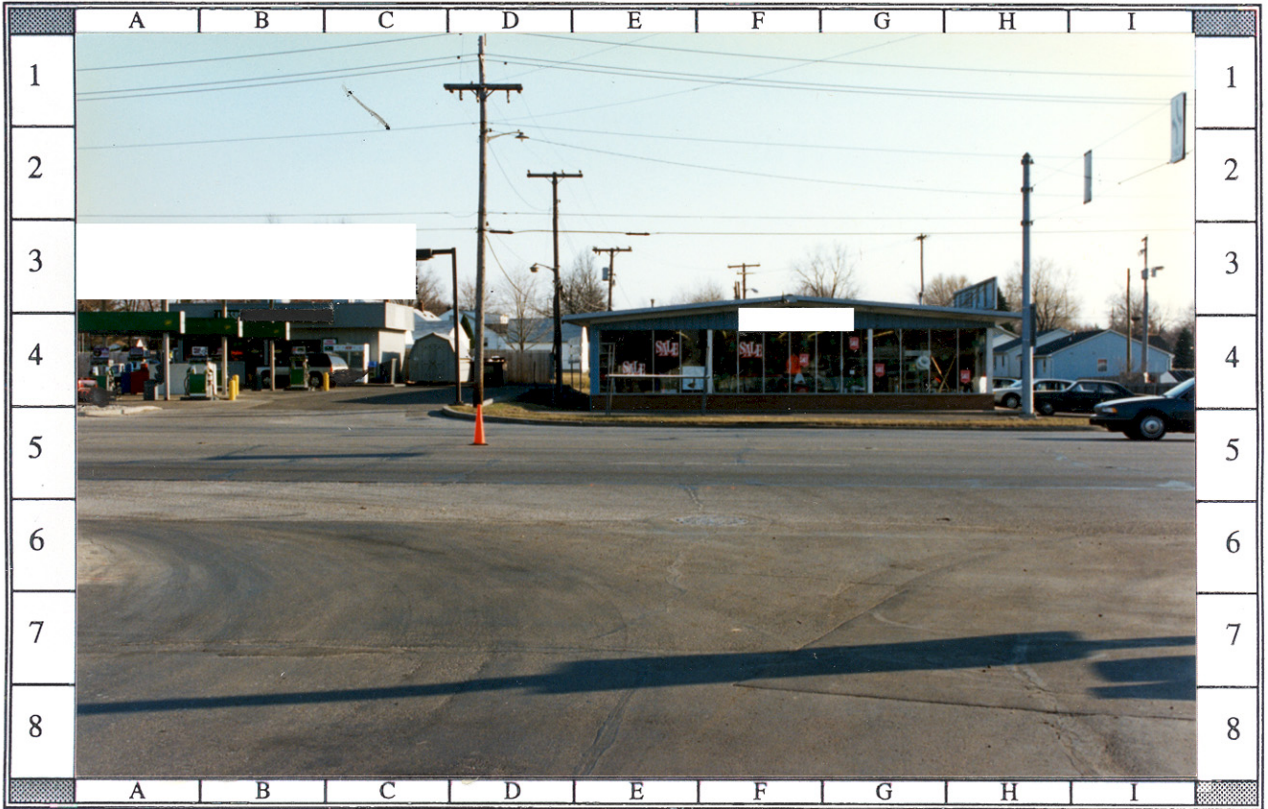
13 -- 1993 Chevrolet C-20 conversion van begins its left-hand turn from driveway located on north side

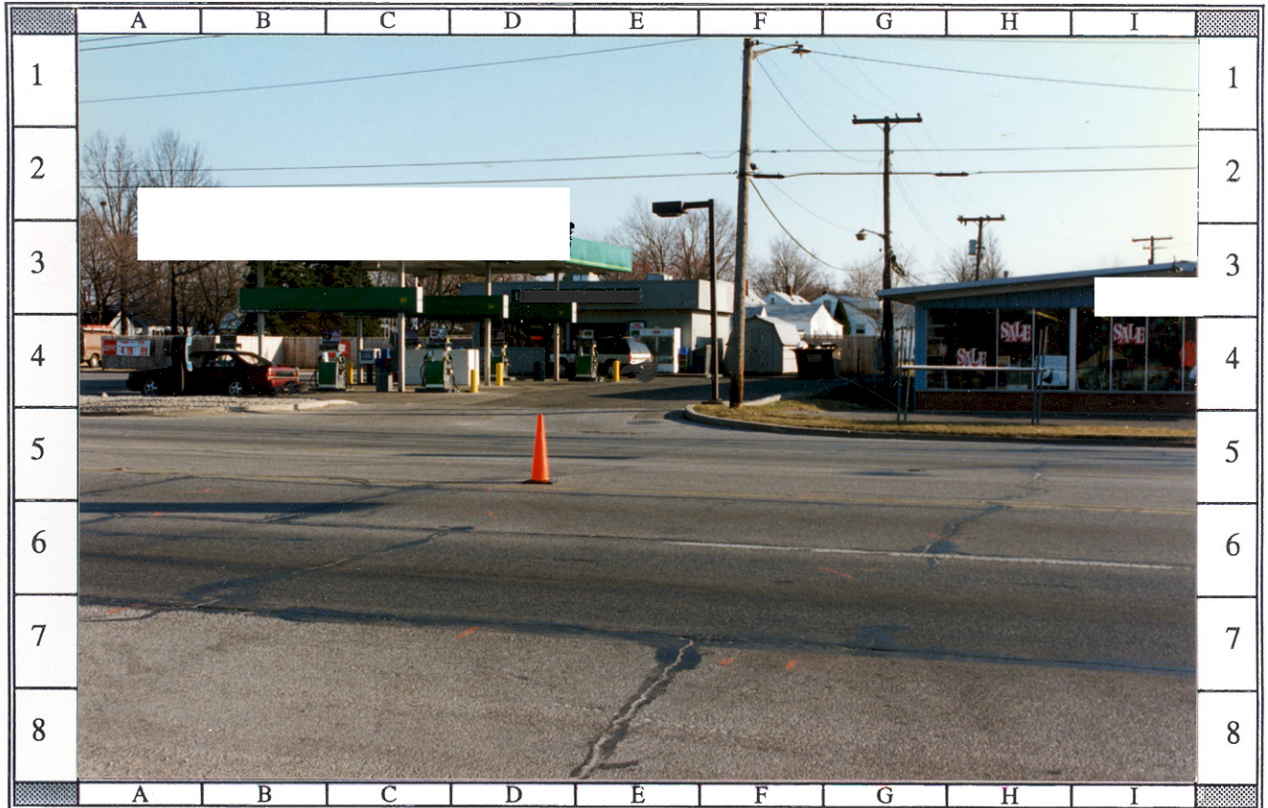
14 -- 1993 Chevrolet C-20 conversion van's south-southeast travel path approximately 8 m (26 ft) from point of impact

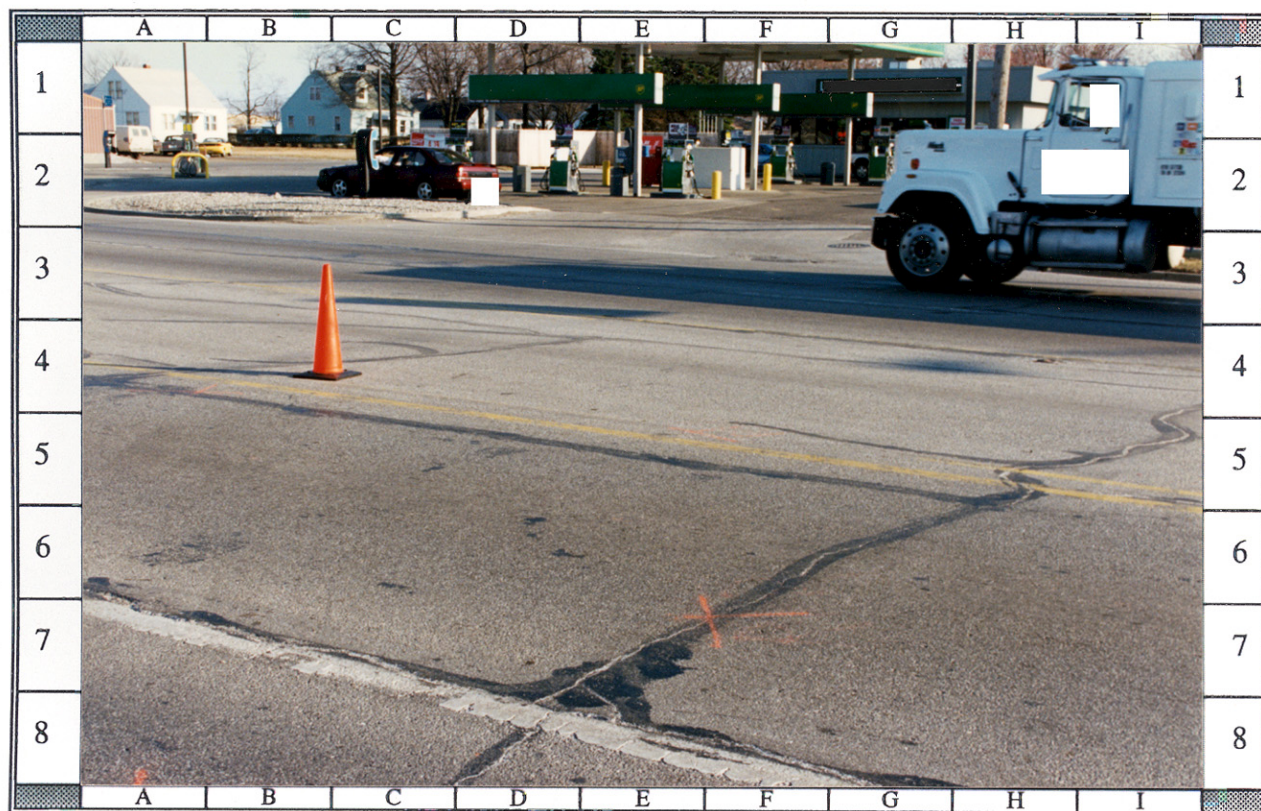
15 -- 1993 Chevrolet C-20 van's point of impact (near red cone) & FRP [cell F5 (RF) & F7 (RR)] straddling inside westbound lane

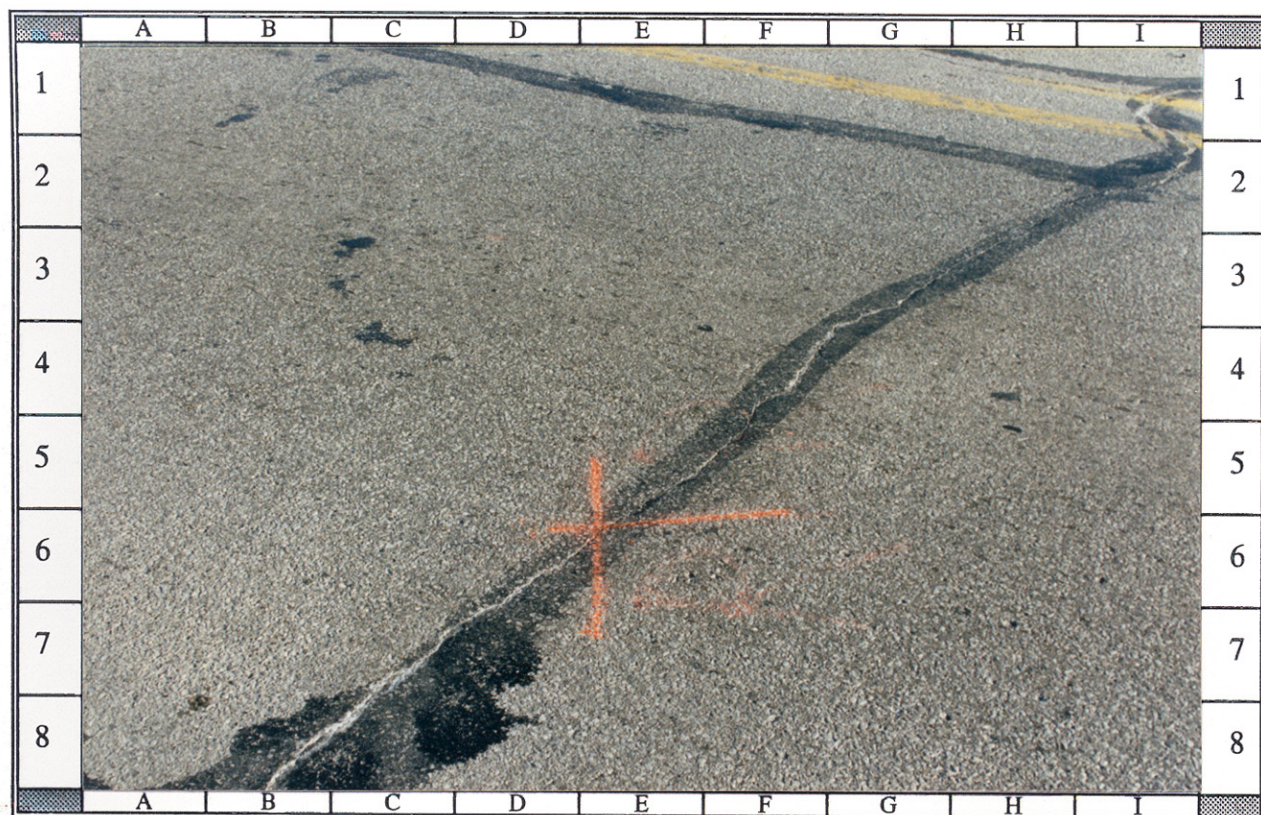
16 -- Southeast view of FRP scene marking symbols representing the '93 Chevrolet C-20 conversion van's right rear tire

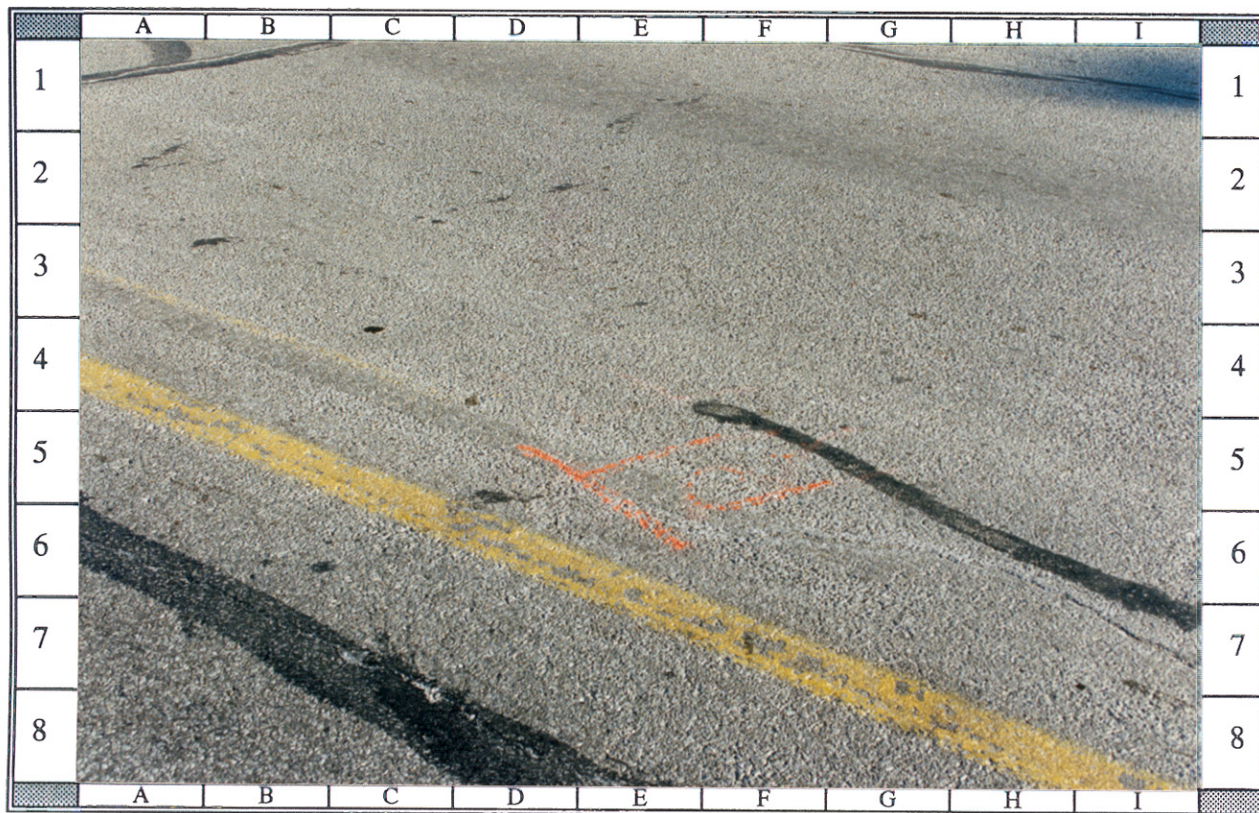
17 -- Southeast view of FRP scene marking symbols representing the '93 Chevrolet C-20 conversion van's right front tire

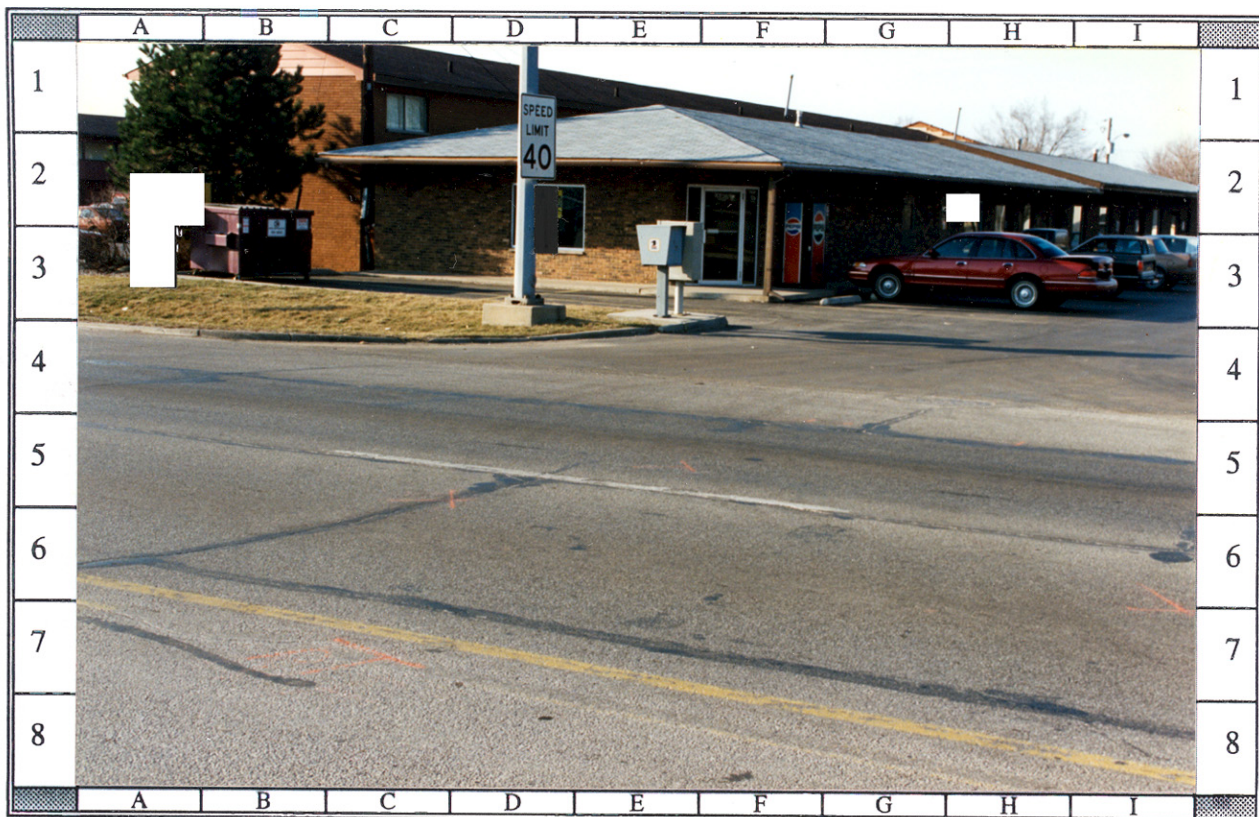
18 -- North-northwest view of FRP scene marking symbols representing the 1993 Chevrolet's FRP [cells C7 (RF), D5 (RR), & E5 (LR)]
